Fisher Maritime LLC

CASUALTY ANALYSIS *

Tiffany Provence v. United States of America, Crowley Government Services, et al. (re Mr. Juan Antonio Villalobos Hernandez)

Crowley Government Services managing the repairs to the
USNS Lummus at Detyens Shipyard Inc. in 2018-2019

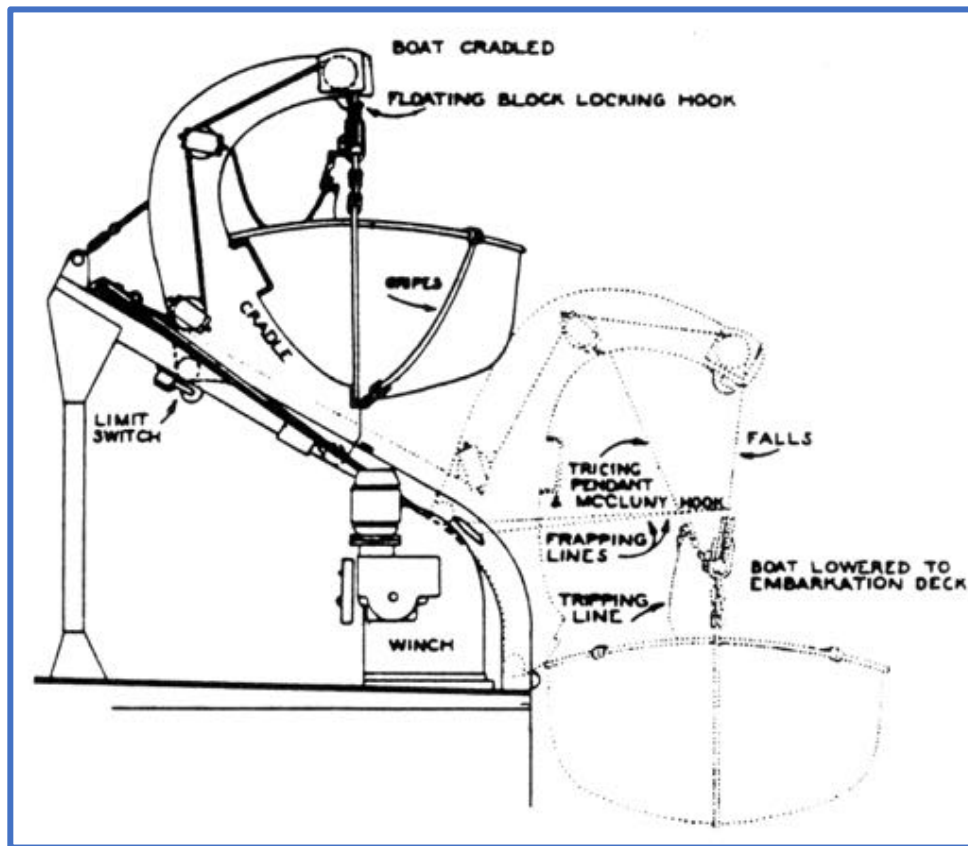
Exhibit FM-1 – Roller Gravity Davit Diagram⁵

[15] Per the manual issued by the supplier of the lifeboat davits when the ship was constructed, *"this equipment is designed to launch, retrieve and stow a lifeboat. The davit consists of a pair of crescent shaped arms mounted on rollers, installed in a pair of inclined trackways, in which the arms travel from the inboard to the outboard positions. The boat is lowered to the water by gravity under control of the centrifugal and manual brakes on the winch. The boat is hoisted from the water and the arms are brought to their stowed position by the winch which can be hand cranked in the event of a power failure."*⁴

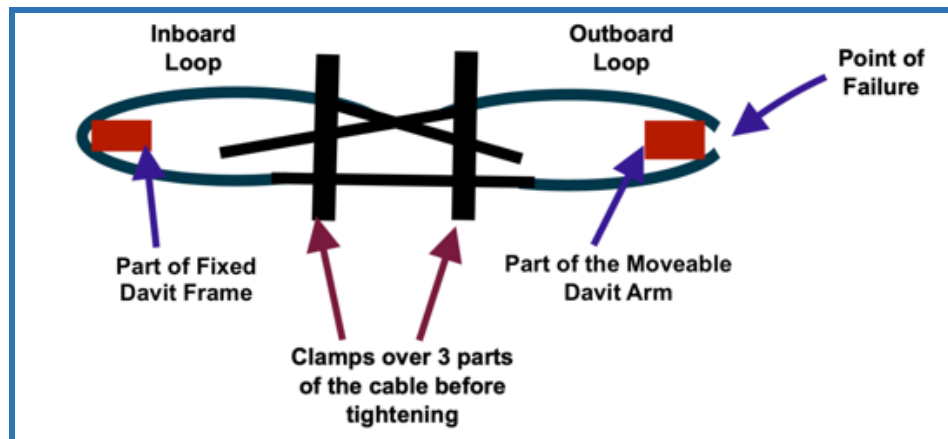
Exhibit FM-2 -- Diagram of Clamping the Restraining Wire rope

had been restrained in the raised position by 3/8" wire rope fastened by clamps to create two loops. One loop was placed around a part of the davit arm, and the other loop was placed around a structural part the davit frame. This was the same method as successfully employed previously on other ship repair projects and on the other 11 davit arms on the Lummus. The two loops overlapped, and were secured together by two Crosby clamps, each clamp enclosing three parts of the wire rope. This arrangement is diagrammatically depicted below in **Exhibit FM-2**. The observed point of failure is also identified in this Exhibit.

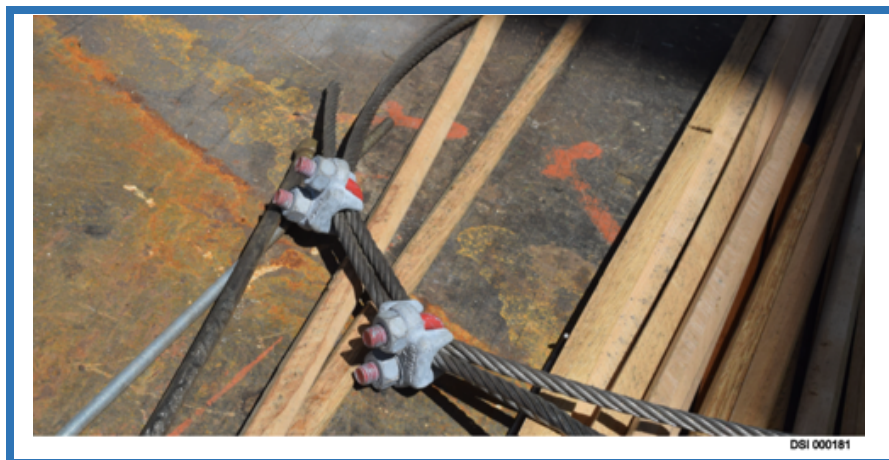
Exhibit FM-3 -- Clamped ends and middle of Restraining Wire rope ⁶

[21] The actual result of such clamping is shown below in **Exhibit FM-3** below, taken from a portion of DSI's Photo No. 000181. The outer loop -- the one that parted later -- passed around part of the davit arm's structure. The inner loop passed around part of the davit frame that is welded to the side of the deckhouse.

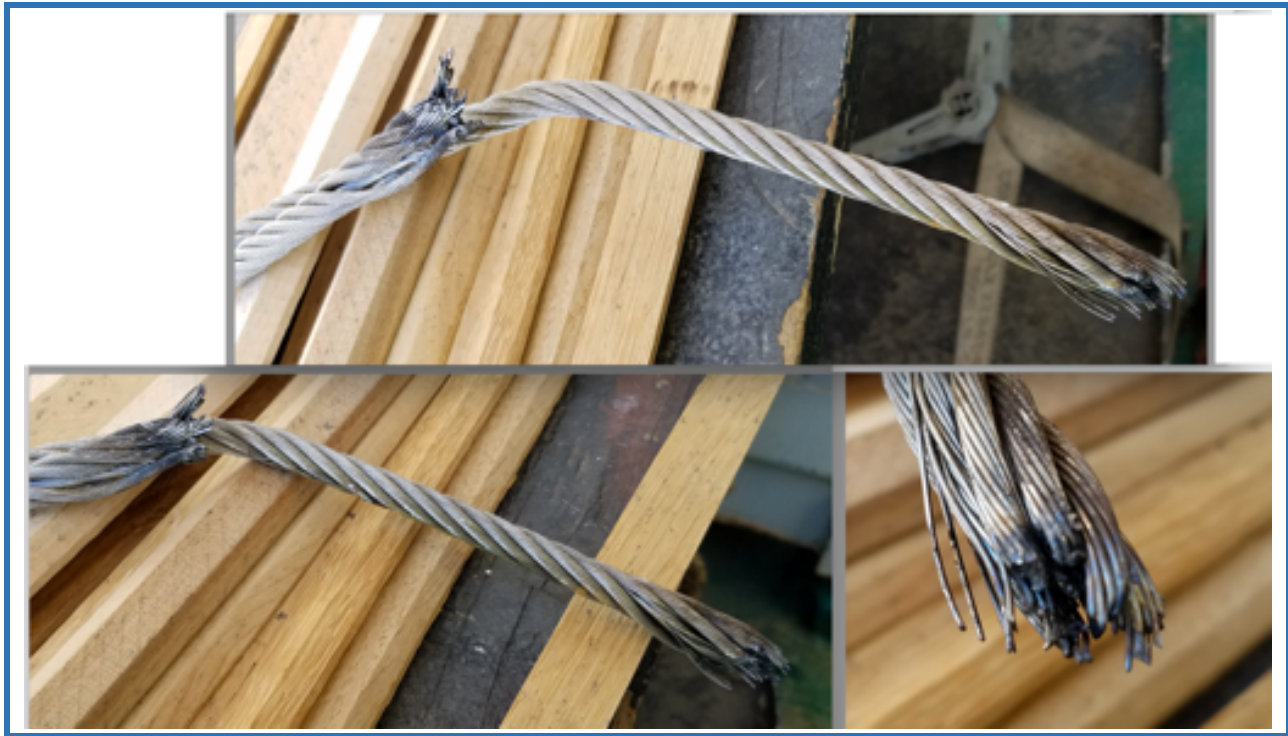
Exhibit FM-4 -- Parted Ends of Restraining Wire Rope ⁹

[35] A necked wire rope, in which nearly all the wires and strands (but not necessarily all of them) have permanent necking is indicative of a failure due to excess tension. Once again, the cited contemporaneous and SLTC photographs (**Exhibit FM-4** and in Figures 8 and 9 of the SLTC report) do not show any permanent necking of the wire rope, its seven strands or nearly all the individual wires, with exception of *"a few of the wires [that] failed in tension demonstrated by necking and shear failure"*. Excess physical tension is thereby eliminated as the primary cause of the wire rope parting. Instead, as described in Section V.3, below, the tensile failure observed in only a few of the wires occurred in the final moments prior to total failure when the weight of the davit arm overcame the strength remaining in the few wires that were not already compromised by another mechanism.

The photographs of the parted ends of the wire rope that have been reviewed (**Exhibit FM-4**, above) show that some of the individual wires failed by melting and fusing with adjacent wires, some melted without fusing to adjacent wires, and others failed in tension.

[51] Examination of the DSI contemporaneous photographs (**Exhibit FM-4**) and those in Figures 8 and 9 of the SLTC report shows that nearly all the individual wires are seen to have separated at slightly different points due to melting, leading to a near-total loss of strength of the wire rope. The few remaining wires were immediately overloaded, stretched and failed in tension.
